Manhole Inspection Summary

Manhole # S15C__024MH

Location Address: **2560 EVERGREEN ST**

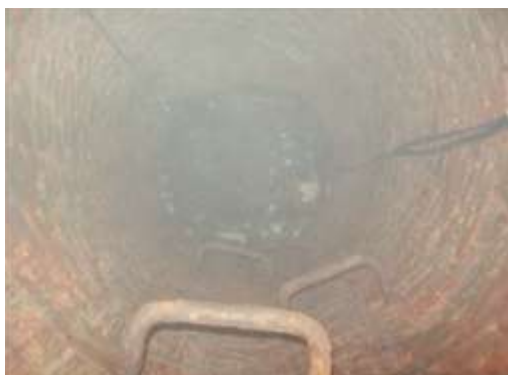
Too Much Steam - Cannot Get Better Top View With Clear Connectivity - Multiple Field Visit

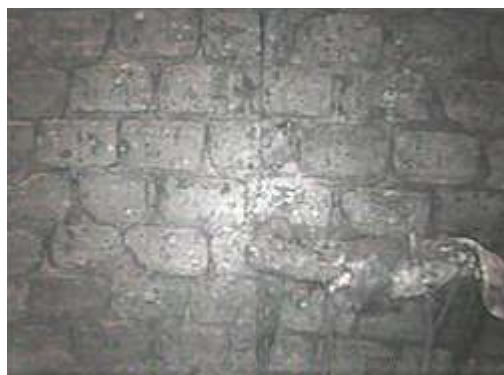
Defect 1

Surcharge ☒ **Evidence Of Surcharge** Depth: **5** (ft.) ☐ Active Surcharge Present

EVIDENCE OF SURCHARGE

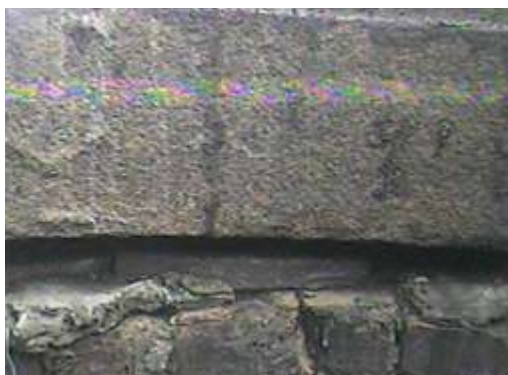
Defect 2

Chimney / Frame Adjustment ☒ Exists Material: **Concrete** ☐ Parged Height: **3** (in.)

Condition: ☐ Sound ☒ **Cracked** ☐ Root Intrusion ☐ Loose Brick ☒ **Deteriorated**

CRACKED / DETERIORATED ADJ.

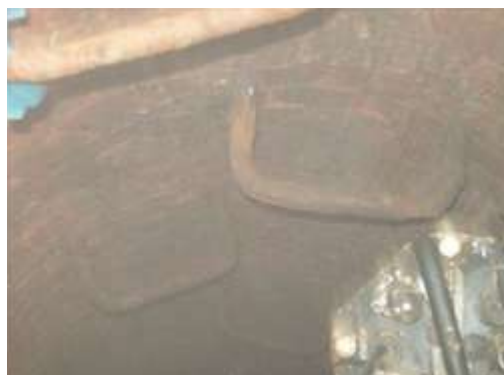
Defect 4

Steps Count: **8** Missing: **0** ☒ **Corroded**

CORRODED STEPS

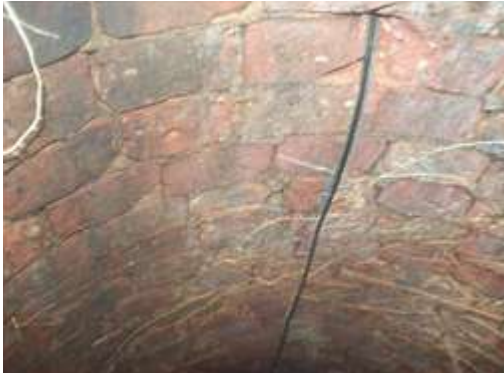
Defect 4

Infiltration: ☐ None ☐ Joint ☐ Cracks ☐ Mortar ☒ **Roots** ☐ Wall

ROOTS ON BARREL

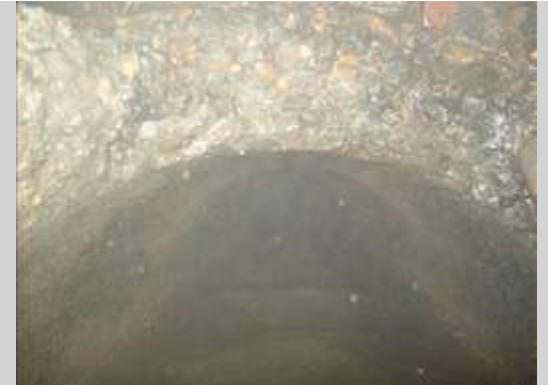
12 O'Clock Outflow

33 in. Circular Gravity Sewer
Pipe Out @ 12 O'Clock

Pipe Height: **28.8** (in.) Rod and Bar
Pipe Material: **Clay** ☐ Pipe Lined
Invert Depth: **19.05** (ft.) Flow Characteristics: **Fast**
Deposits: ☐ None ☐ Mud ☐ Sludge ☒ Debris ☒ Grease
Silt Depth: **4** (in.) Deposits Extent: **Medium**
Infiltration: **None** Pipe Seal Cond: **Unknown**

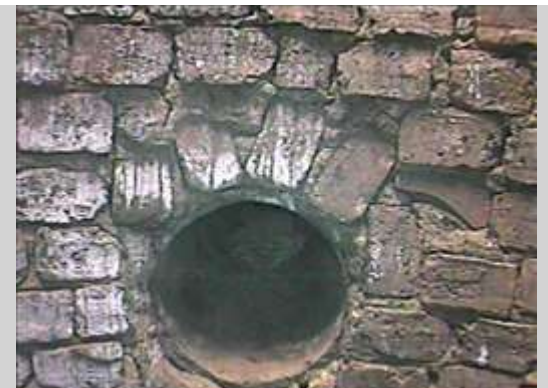
3 O'Clock Inflow

8 in. Circular Gravity Sewer
Pipe In @ 3 O'Clock

EVIDENCE OF SURCHARGE

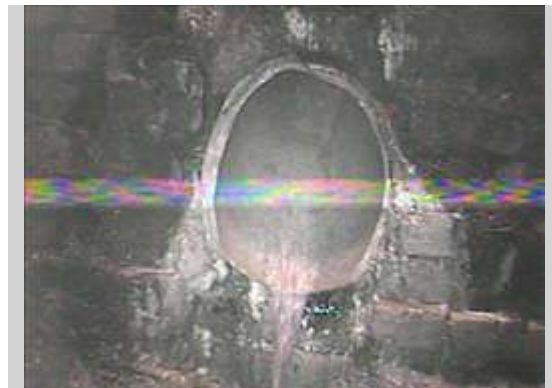
Drop In @ 3 O'Clock

EVIDENCE OF SURCHARGE

Pipe Height: **7.2** (in.) Rod and Bar
Pipe Material: **Clay** ☐ Pipe Lined
Invert Depth: **5.49** (ft.) Flow Characteristics: **Fast**
Deposits: ☒ None ☐ Mud ☐ Sludge ☐ Debris ☐ Grease
Silt Depth: (in.) Deposits Extent:
Infiltration: **None** Pipe Seal Cond: **Sound**

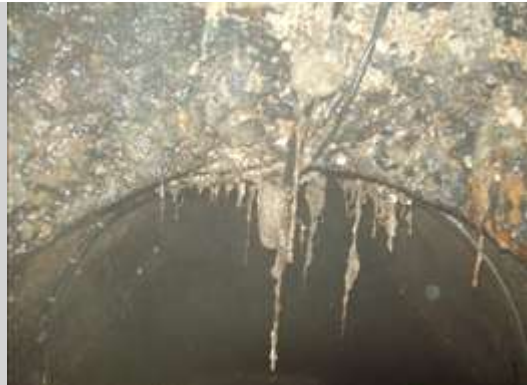
6 O'Clock Inflow

33 in. Circular Gravity Sewer
Pipe In @ 6 O'Clock

Deposits: ☐ None ☐ Mud ☐ Sludge ☐ Debris ☒ **Grease**

Silt Depth: **4** (in.) Deposits Extent: **Medium**
